**Flood Control Project Maintenance
Levee Inspections****LMA District Cover Sheet****Spring 2015 Levee Inspection Results****Reclamation District No. 0827 Elkhorn**

Levee Inspection Report By Mile - Spring 2015

Reclamation District No. 0827 Elkhorn

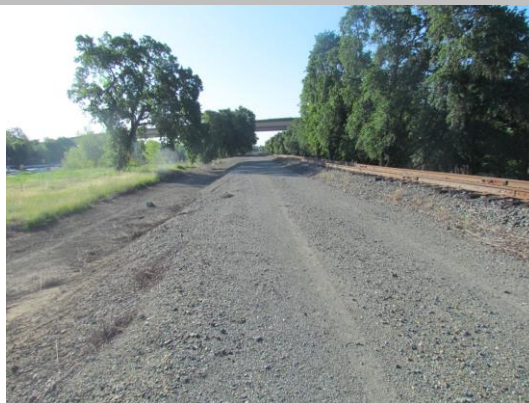
Photo 1 of 1 : SP_2015_RD0827_187_211_20150415_00009.jpg

LM Start	0.03	Rating **	A	Issue No.	211
LM End	0.03	Issue Type +	Ma	Location *	WS
Category	Earthen Levee			GPS Latitude/Longitude	
				Start	End
Item	Vegetation			38.674890 °	38.674890 °
				-121.630042 °	-121.630042 °
DWR ID	DWR_RD0827_01_s _ 2015_211				
Action/Comments					
Control annual grass and weeds on the levee slopes and easements.

View of the vegetation on the waterward side of the levee looking downstream. Spring 2015.

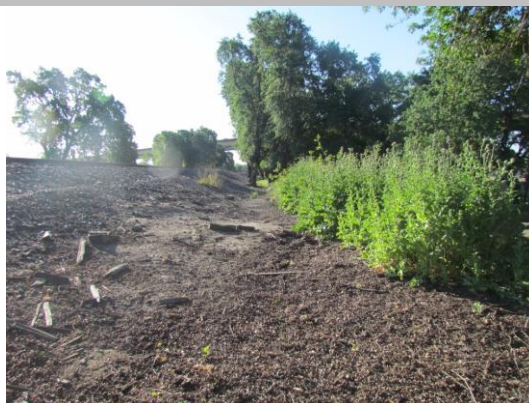
Photo 1 of 1 : SP_2015_RD0827_187_212_20150415_00010.jpg

LM Start	0.03	Rating **	A/W	Issue No.	212
LM End	0.25	Issue Type +	Ma	Location *	LS
Category	Earthen Levee			GPS Latitude/Longitude	
				Start	End
Item	Vegetation			38.674890 °	38.672602 °
				-121.630042 °	-121.627233 °
DWR ID	DWR_RD0827_01_s _ 2015_212				
Action/Comments					
Control annual grass and weeds on the levee slopes and easements.

View of the vegetation on the landward side of the levee looking downstream. Spring 2015.

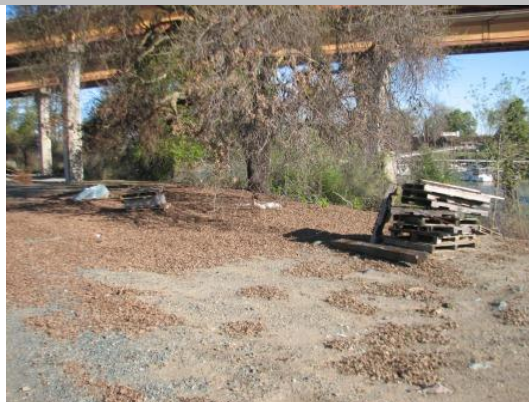
Photo 1 of 1 : SP_2015_RD0827_187_108_20150401_00006.jpg

LM Start	0.25	Rating **	M	Issue No.	108
LM End	0.25	Issue Type +	En	Location *	CR
Category	Earthen Levee			GPS Latitude/Longitude	
				Start	End
Item	Encroachments			38.672654 °	38.672654 °
				-121.627242 °	-121.627242 °
DWR ID	DWR_RD0827_01_s _ 2014_108				
Action/Comments					
Debris

Pallets and debris from the rail road left on levee crown. Spring 2014

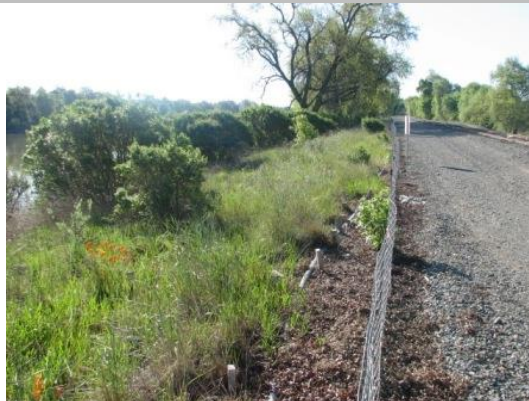
Photo 1 of 5 : SP_2015_RD0827_187_22_20150401_00001.jpg

LM Start	0.61	Rating **	A/W	Issue No.	22
LM End	0.92	Issue Type +	Ma	Location *	WS
Category	Earthen Levee			GPS Latitude/Longitude	
				Start	End
Item	Vegetation			38.668873 °	38.665750 °
				-121.622513 °	-121.618523 °
DWR ID	DWR_RD0827_01_s_2012_22				
Action/Comments					
Environmental Requirements.

Revegetation site with fencing, irrigation and stakes to hold netting.
Photo taken spring 2012.

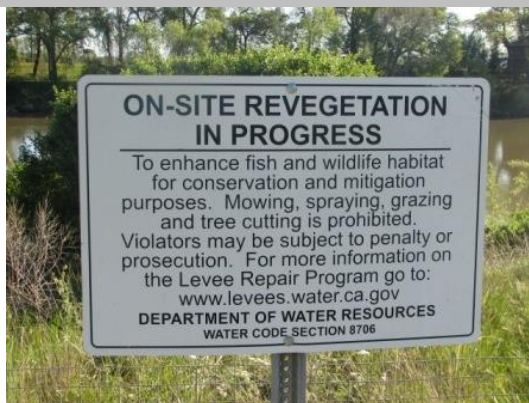
Photo 2 of 5 : SP_2015_RD0827_187_22_20150401_00002.jpg

Revegetation site spring 2012.

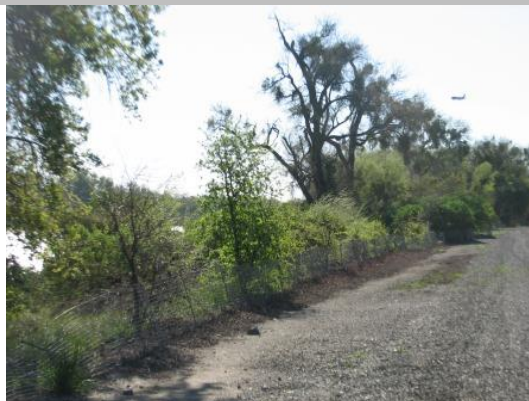
Photo 3 of 5 : SP_2015_RD0827_187_22_20150401_00003.jpg

Another view of the revegetation site. Spring 2014

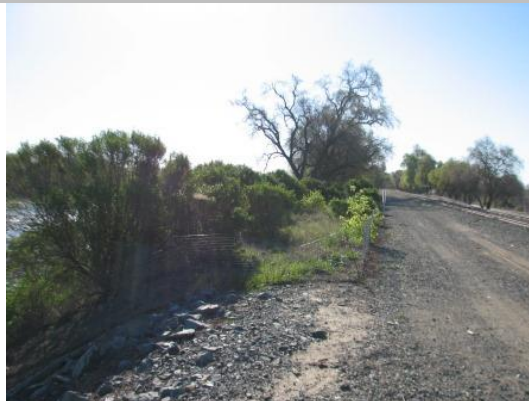
Photo 4 of 5 : SP_2015_RD0827_187_22_20150401_00004.jpg

LM Start	0.61	Rating **	A/W	Issue No.	22 (cont)
LM End	0.92	Issue Type +	Ma	Location *	WS
Category	Earthen Levee			GPS Latitude/Longitude	
				Start	End
Item	Vegetation			38.668873 °	38.665750 °
				-121.622513 °	-121.618523 °
DWR ID	DWR_RD0827_01_s_2012_22				
Action/Comments					
Environmental Requirements.

The vegetation continues to grow taller. It makes visibility hard. Spring 2014

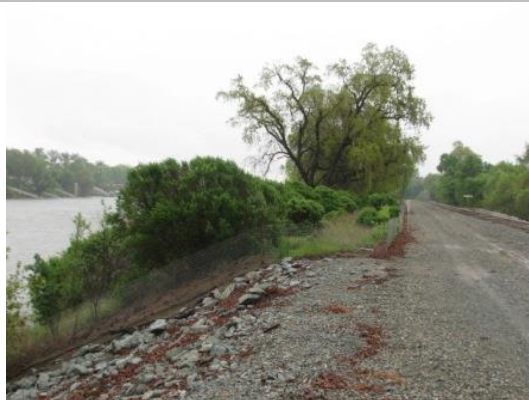
Photo 5 of 5 : SP_2015_RD0827_187_22_20150401_00005.jpg

The revegetation site has grown and blocks visibility. Spring 2013

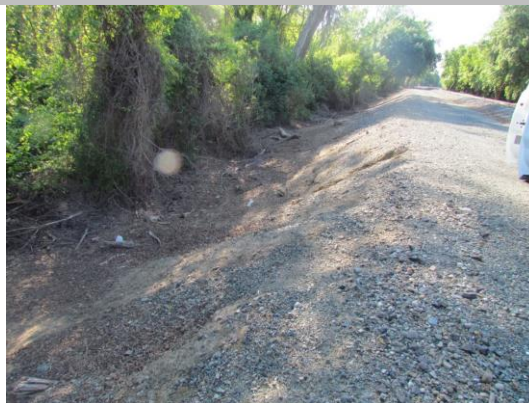
Photo 1 of 1 : SP_2015_RD0827_187_213_20150415_00012.jpg

LM Start	0.93	Rating **	M	Issue No.	213
LM End	0.93	Issue Type +	Ma	Location *	WS
Category	Earthen Levee			GPS Latitude/Longitude	
				Start	End
Item	Slope Stability			38.665652 °	38.665652 °
				-121.618385 °	-121.618385 °
DWR ID	DWR_RD0827_01_s _ 2015_213				
Action/Comments					
Repair slope instability.

View of the depression on the water ward side of the levee looking downstream. Spring 2015.

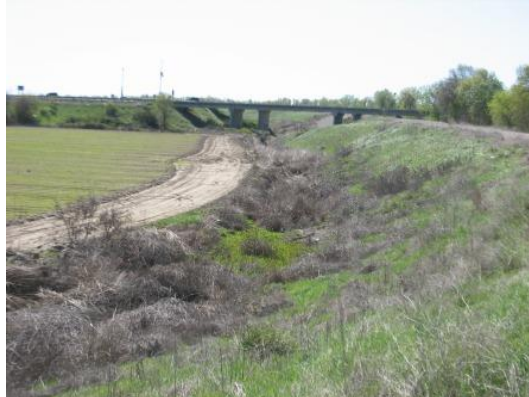
Photo 1 of 2 : SP_2015_RD0827_188_2_20150401_00001.jpg

LM Start	0.02	Rating **	M	Issue No.	2
LM End	0.52	Issue Type +	En	Location *	LS
Category	Earthen Levee			GPS Latitude/Longitude	
				Start	End
Item	Encroachments			38.676440 °	38.669401 °
				-121.642747 °	-121.641417 °
DWR ID	DWR_RD0827_02_f_2012_2				
Action/Comments					
Ditch

The ditch run along the landside slope. Spring 2014

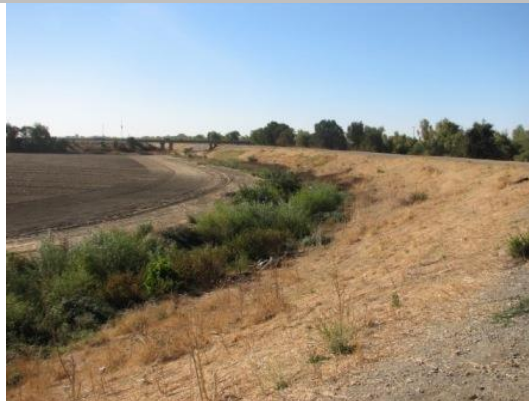
Photo 2 of 2 : SP_2015_RD0827_188_2_20150401_00002.jpg

Ditch runs along the landside toe. Photo fall 2012.

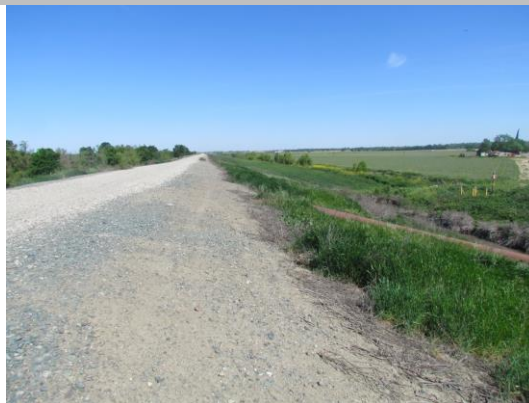
Photo 1 of 1 : SP_2015_RD0827_188_386_20150415_00009.jpg

LM Start	0.15	Rating **	M	Issue No.	386
LM End	2.74	Issue Type +	Ma	Location *	LS
Category	Earthen Levee			GPS Latitude/Longitude	
				Start	End
Item	Vegetation			38.674652 °	38.641751 °
				-121.642858 °	-121.620787 °
DWR ID	DWR_RD0827_02_s _ 2015_386				
Action/Comments					
Control annual grass and weeds on the levee slopes and easements.

View of the vegetation on the landward side of the levee looking upstream. Spring 2015.

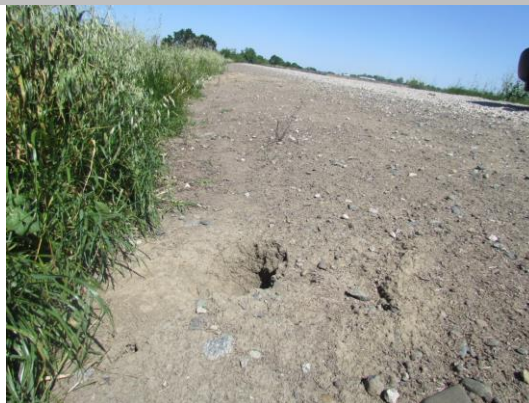
Photo 1 of 1 : SP_2015_RD0827_188_390_20150415_00011.jpg

LM Start	0.64	Rating **	M	Issue No.	390
LM End	0.64	Issue Type +	Ma	Location *	WS
Category	Earthen Levee			GPS Latitude/Longitude	
				Start	End
Item	Animal Control			38.667880 °	38.667880 °
				-121.640587 °	-121.640587 °
DWR ID	DWR_RD0827_02_s _ 2015_390				
Action/Comments					
No rodents visible, but rodent burrows visible; need to backfill and compact or grout burrows.

View of the burrow on the water ward side of the levee looking upstream. Spring 2015.

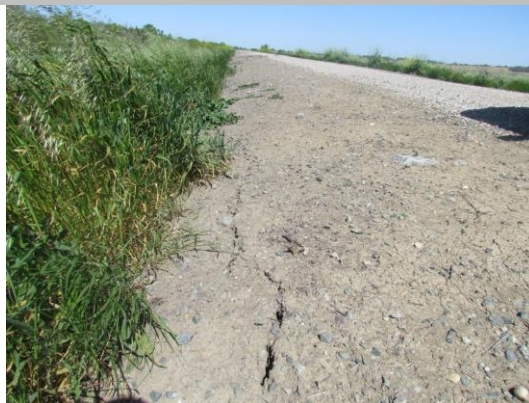
Photo 1 of 1 : SP_2015_RD0827_188_389_20150415_00010.jpg

LM Start	1.40	Rating **	M	Issue No.	389
LM End	1.40	Issue Type +	Ma	Location *	WS
Category	Earthen Levee			GPS Latitude/Longitude	
				Start	End
Item	Cracking			38.658877 °	38.658877 °
				-121.632550 °	-121.632550 °
DWR ID	DWR_RD0827_02_s _ 2015_389				
Action/Comments					
Monitor and have inspected by geotechnical engineer.

View of the crack on the water ward side of the levee looking upstream.
Spring 2015.

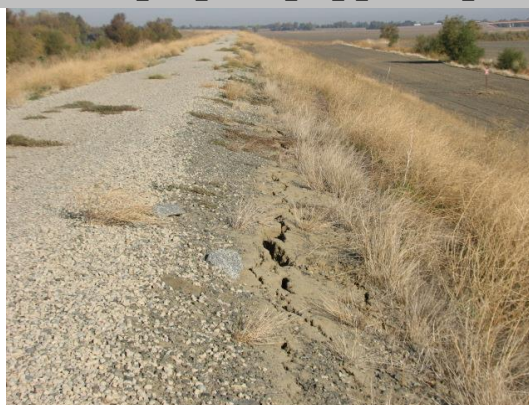
Photo 1 of 1 : SP_2015_RD0827_188_5_20150401_00006.jpg

LM Start	2.01	Rating **	U	Issue No.	5
LM End	2.13	Issue Type +	Ob	Location *	CR
Category	Earthen Levee			GPS Latitude/Longitude	
				Start	End
Item	Cracking			38.651316 °	38.649804 °
				-121.626680 °	-121.625759 °
DWR ID	DWR_RD0827_02_f _ 2013_5				
Action/Comments					
Monitor and have inspected by geotechnical engineer.

The crack is 4-6 inches wide and 3 feet deep with a length of 6 feet. Fall 2013

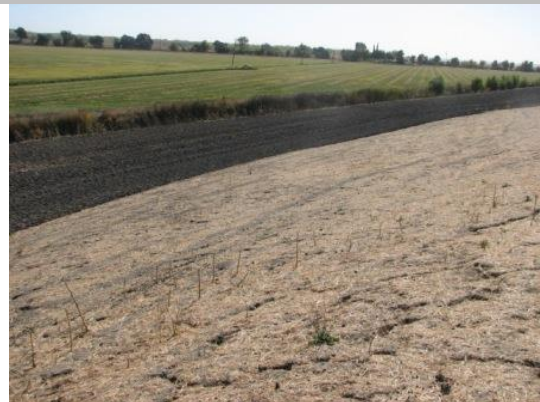
Photo 1 of 1 : SP_2015_RD0827_188_24_20150401_00008.jpg

LM Start	2.29	Rating **	M	Issue No.	24
LM End	2.29	Issue Type +	Ma	Location *	LS
Category	Earthen Levee			GPS Latitude/Longitude	
				Start	End
Item	Slope Stability			38.647703 °	38.647703 °
				-121.624450 °	-121.624450 °
DWR ID	DWR_RD0827_02_s _ 2012_24				
Action/Comments					
Repair slope instability. Inspector Comments: There is cracking along the levee slope not greater than 200 feet. Need to monitor.

A bulge in the levee slope. Photo fall 2012.
